**STATE OF TENNESSEE
DEPARTMENT OF ENVIRONMENT AND CONSERVATION
COOKEVILLE ENVIRONMENTAL FIELD OFFICE**

RE: Results of Site Inspection
American Sand 50 Acre Tract, NPDES Permit # TN0066231
Putnam County

TDEC DWR Photo Log
Permit Renewal Inspection, 08-26-13
By Sharon Kington, ES3

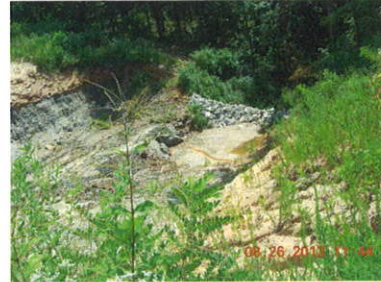
1. DMP 001 "Basin" has no dam,
only a rock filter berm across the opening.
Note water trickle, but site reports no discharge.

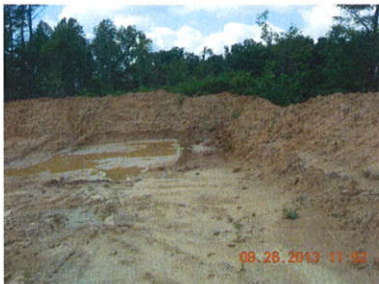
2. Basin 002 area has been surrounded by loose berms rather than excavated, due to shallow bedrock. Also drainage path is altered from plan, with much of drainage diverted to incomplete Basin 001.

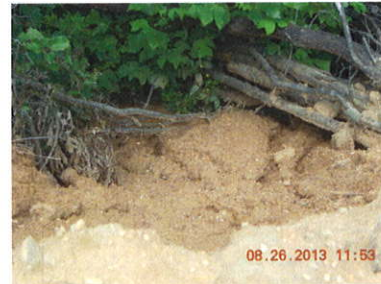
3. The berms surrounding the DMP 002 area are eroding toward the stream channel, but so far are caught by vegetation.

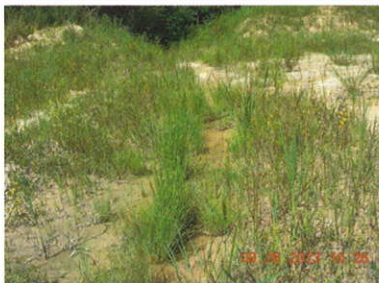
4. Downhill flow path from overfull basin 003 to DMP 003 spillway. Basin 003 is to designed as seven feet deep.

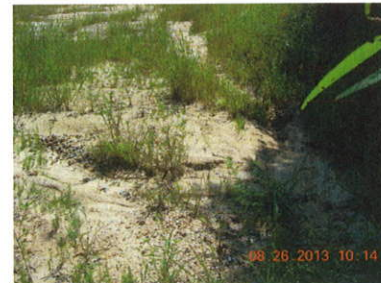
- Failure to Implement Plan: Installation of sediment basins for the three significantly disturbed drainage areas does not match the approved plan.
- Improper Operation and Maintenance: Basin 003 is completely filled with sand, and sediment is leaving the site via that spillway.

5. Basin 003 is totally filled and overflowing with sand; photo taken near spillway looking back (east) toward back of basin.

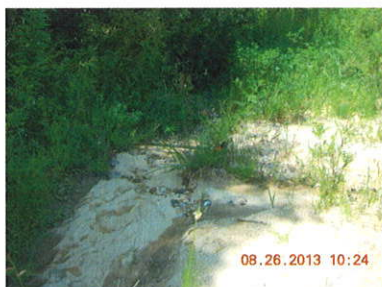
6. DMP 003 spillway shows lack of retention and sand loss.

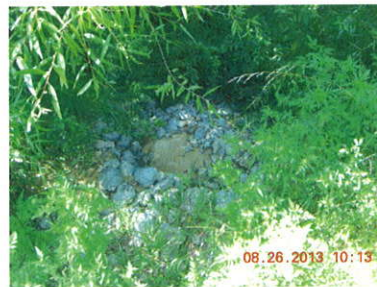
7. 003 Spillway has aluminum slag "clinkers" still in place; Also note sand deposition as it leaves site.

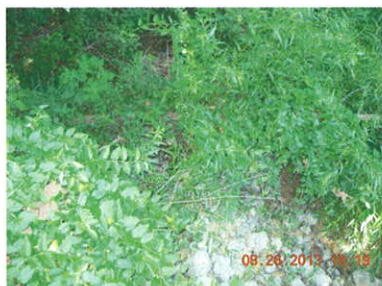
8. Sand has moved past spillway at DMP003.

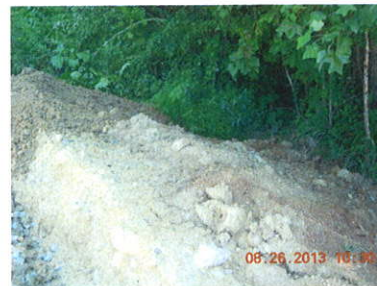
9. Bare unstabilized berm north side of Rocky Pt Rd, along access road near Basin 003 area. Most of the site is disturbed, though no basin has been completed as shown in plan.

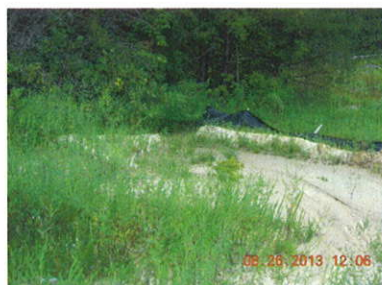
- Impact to State waters: Minor amounts of sediment have entered the excluded wetland area due to failure to maintain entrance haulroad silt fence BMPs.

10. Sediment loss to the excluded wetland has resulted from recent failure to maintain BMPs below south side entrance road.

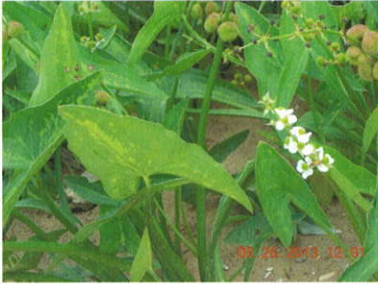
12. Arrowhead is becoming established above culvert and outside area originally designated as wetland.

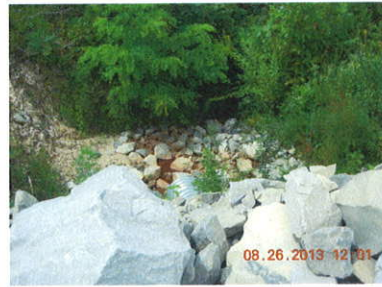
13. Culvert ARAP is deficient and has an eroding channel wall, and rip rap loss to stream. (Photo faces d/s.)

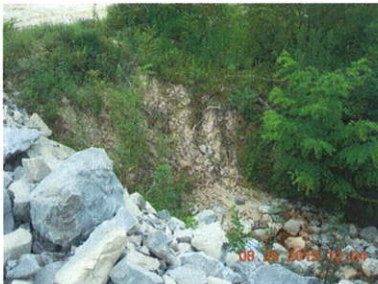
14. Photo taken of ARAP culvert facing eroding channel wall.

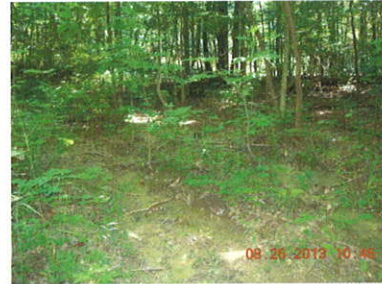
15. Drainage path for DMP 004 through forested area. Basin 4 is under construction.

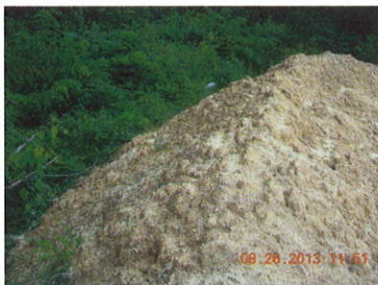
16. Material being used for dam at Basin 004 has a high sand content and needs engineering evaluation.

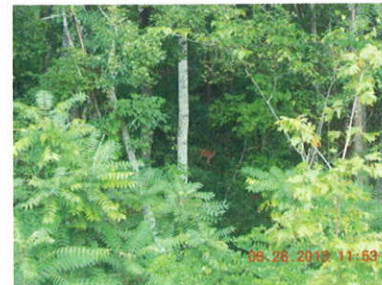
17. Area of Basin 005 is still undisturbed by mining activity.

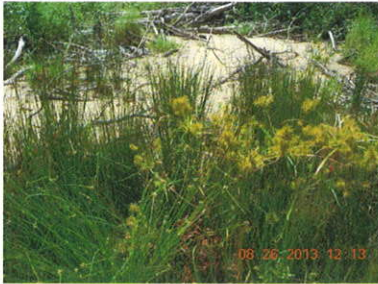
18. Wetland area is developing between access road to DMP 005 area and stream channel. Road erosion has resulted in sediment deposition in this area.
